***Direct Visual Signaling as a Means for  
Occupant Notification in Large Spaces  
Research Project***

*Technical report*

# **Direct Visual Signaling as a Means for Occupant Notification in Large Spaces**

**An Engineering Study Sponsored by  
the Fire Protection Research Foundation**

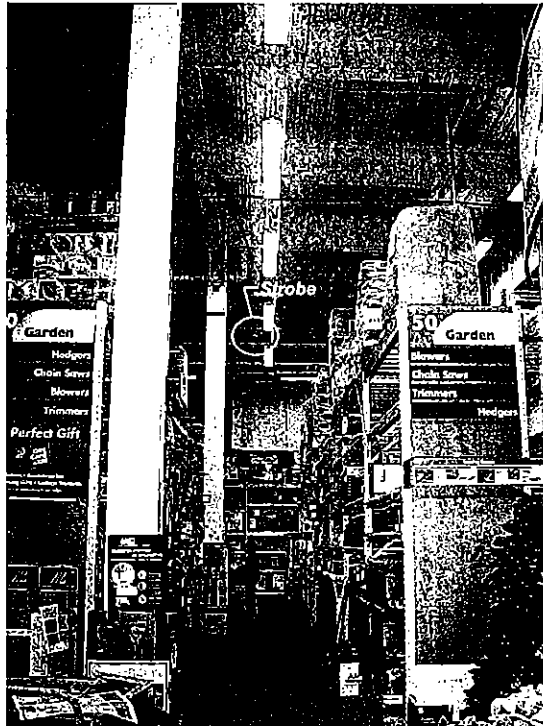
Photo 1 shows a picture of a typical rack aisle with a strobe located directly overhead. A close-up of the strobe in Photo 2 shows the ceiling configuration and the location of the strobe relative to the building lights and structural steel.

Photo 1 - Strobe Over Aisle (Reading, MA)

The strobes at this location are located below the ceiling, at about the same level of the hanging fluorescent lights. The original design called for the strobes to be located over the aisles, between racks. Within each aisle, the strobes are spaced approximately 45 to 48 ft. Rack spacing varies with most 16 ft on center and some as much as 30 ft on center. Thus, strobe coverage might be 45 ft x 16 ft in order to provide a line of strobes in each rack aisle. However, after the system was installed, the rack layout was altered resulting in many lines of strobes not falling directly over an aisle.
